1 **UAV Bridge Inspection through Evaluated 3D Reconstructions**

10 **Abstract**

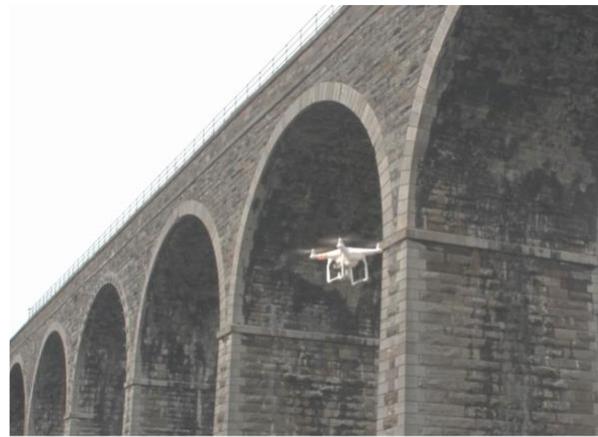
**Fig. 16.** UAV showing the south side of arches 1-6

349 A relatively low end UAV in the form of a DJI Phantom 4 quadrotor (Figure 16) was employed  
350 with a 12-megapixel (4000x3000) digital camera. This commercial unit was augmented with a 3-  
351 axis stabilization gimbal. While more expensive UAVs and cameras are available, the purpose of  
352 this flight was to show the proposed framework in a real-life scenario.

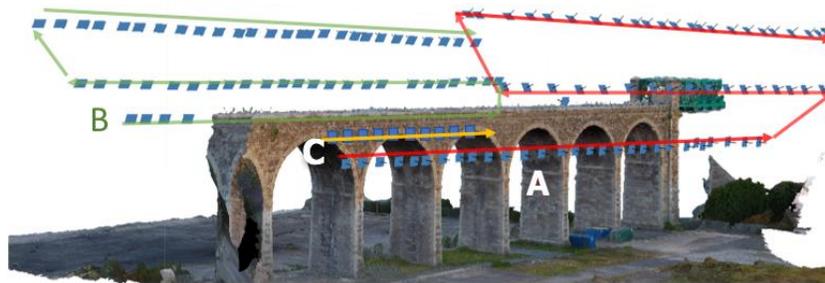
364  
 365 **Fig. 17.** Flight path on both sides (image showing south side of arches 1-6)

354 The flight trajectory was pre-designed as per Figure 17. On each side of the bridge's southern end,  
355 take offs A and B included 3 flight paths with angles ranging from 0° to 45° and offset distances  
356 of 20 m to 40 m (Table 2). To obtain additional details for surface deterioration, a third take off  
357 was undertaken. Arch No. 5 was selected as the target, because a small spalled area was manually  
358 identified during a ground-based pre-check. To document this area in a more detailed manner, 10

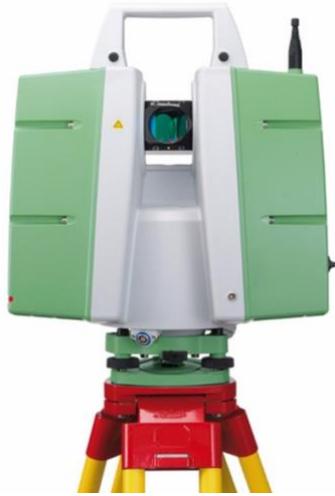
Fig. 18. Terrestrial laser scanner

369 For collection of reference data, a Leica Scan Station P20 terrestrial laser scanner was used (Figure  
 370 18). The unit's resolution was set as 12.5 mm at 10 m resulting in a typical data density of 6400  
 371 pts/m<sup>2</sup>. Scans were taken from 3 locations (see Figure 19) along the southeast portion of the bridge  
 372 and required approximately 1.5 hours in total. As the bridge deck was not accessible, the terrestrial  
 373 laser scan data only covered the side of the bridge.
