Uncertainty Analysis of the Effect of Grout Injection on the Deformation of Multi-Wythe Stone Masonry Walls

The eighteenth century Prince of Wales Fort in Manitoba Canada has experienced extensive freeze-thaw damage and mortar washout within the escarp walls resulting in distress and failures at multiple locations. Injection of grout could counteract this degradation of structural stability. However existing literature provides little guidance as to the improvement level that could be expected, especially with respect to out-of-plane performance. As such, the proposed treatment was modelled to include a high level of uncertainty in the system through the application of a Random Field Finite Element Micro-modelling technique. A Latin Hyper cube simulation method was used in conjunction with a parametric finite element model to randomize the material properties of each stone and relevant grouting layer. The numerical results predicted that the stone-grout bond was the most critical parameter in the proposed intervention, and that in the grouted wall sections, collapse would be avoided and lateral displacements stabilized with the proposed treatment.

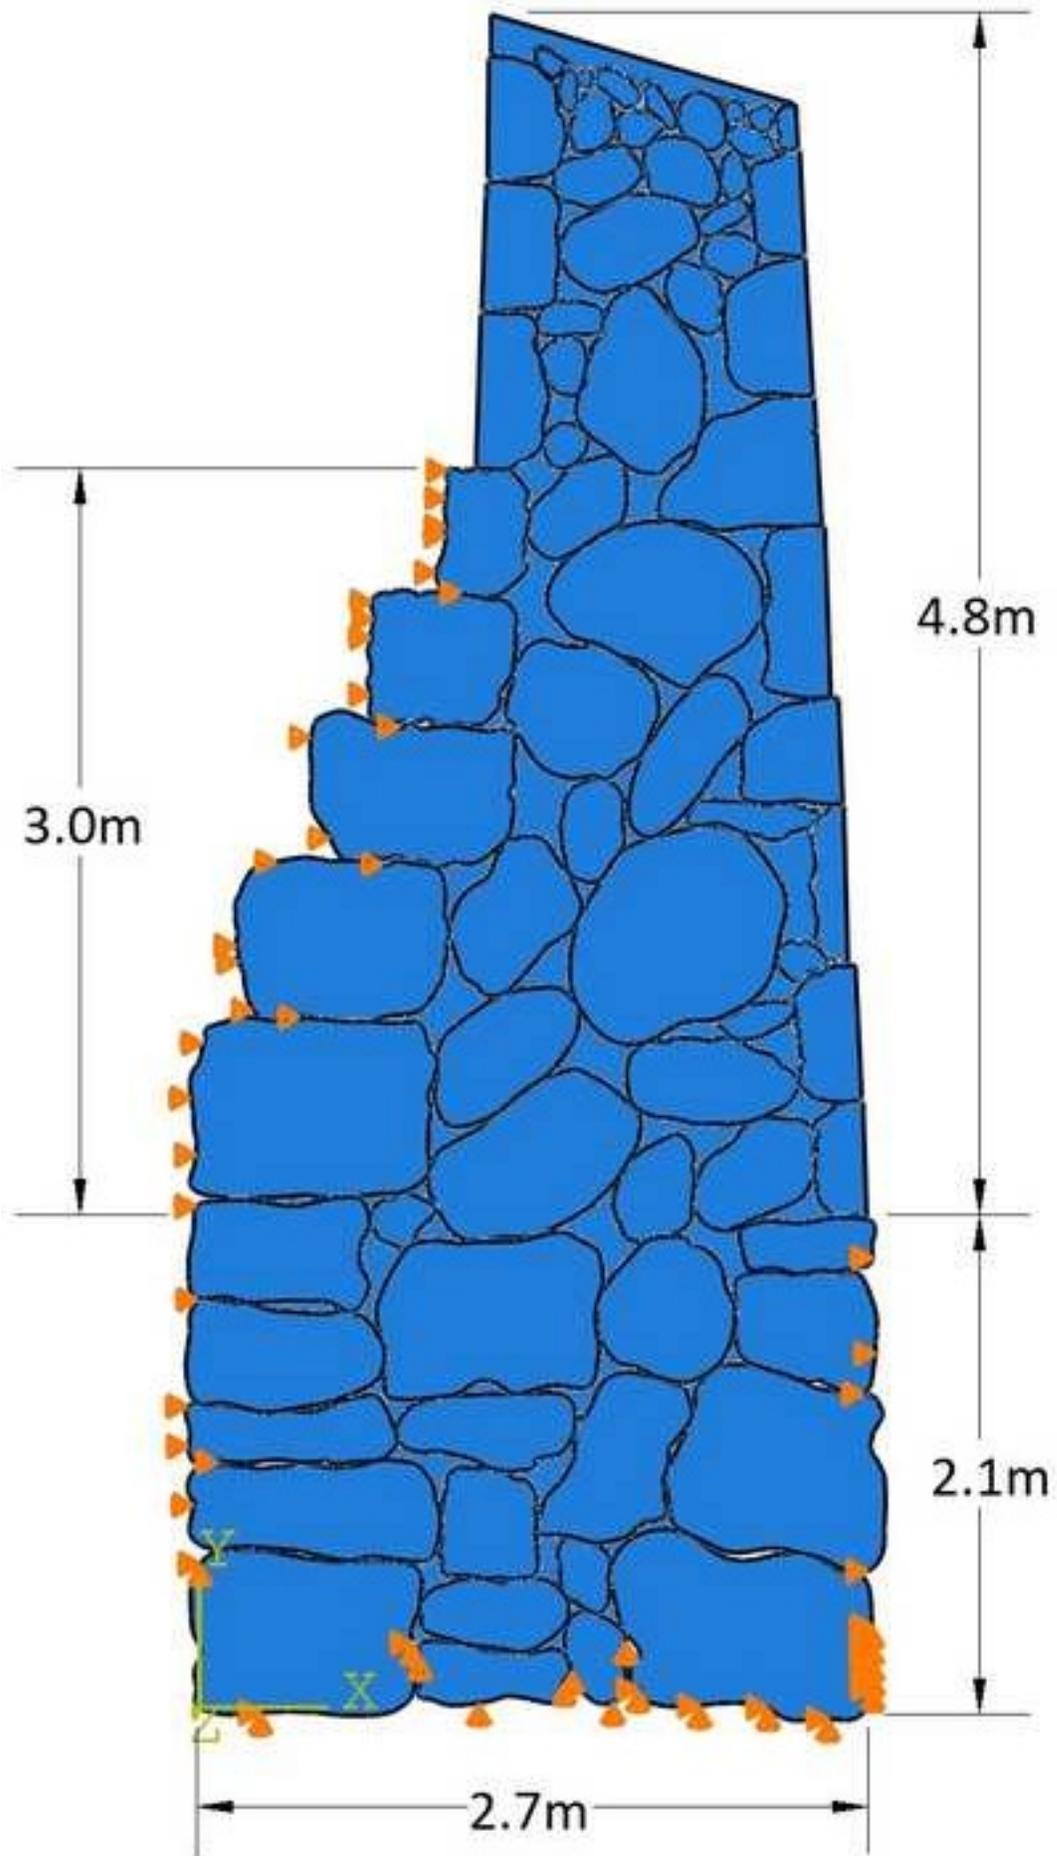
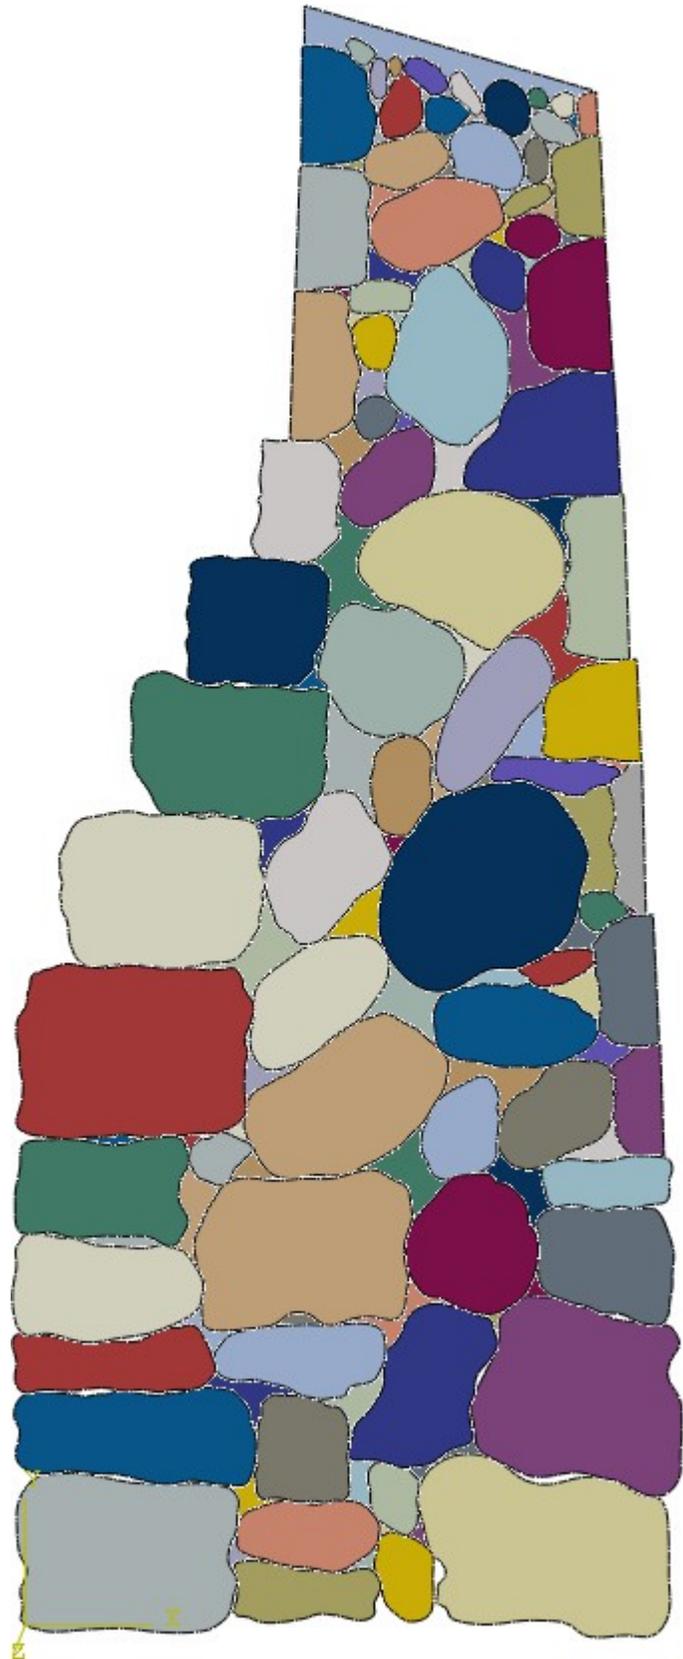
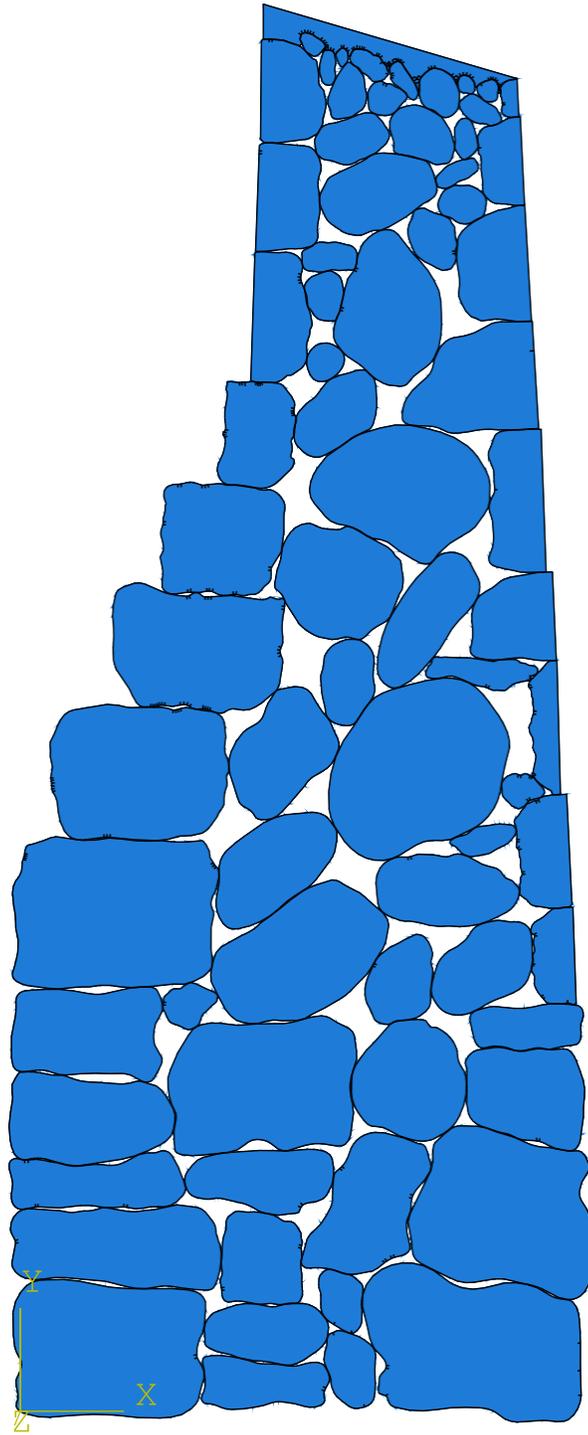
The wall cross-section was developed using data collected during the ongoing conservation project. First, the face stone geometry was acquired through direct measurement and scaled photographs of stones removed during the restoration work. Next, for the material within the wall, stone shapes were traced from images of the wall core after face stone removal. Distinguishing between the original and new material in the images was necessary, as the core was stabilized with flat stones and mortar. The parts were meshed using linear quadrilateral elements, and the final mesh and geometry were established according to the mesh refinement study outlined previously by Isfeld and Shrive [22]. The model geometry and boundary conditions are shown in Figure 5a.

The boundary conditions were considered fixed in the vertical direction along the base and fixed in the horizontal direction to the top of the earthen rampart on the inner face but only up to the ground level on the outer foundation face. To examine the behaviour of the wall cross-section, only self-weight was considered. In [22] a base model was established to show the failure of the cross section of the wall under the extreme case of full mortar degradation and wash-out. The walls were shown to be unable to maintain stability under self-weight in this deteriorated state. Self-weight was seen as the dominant load, as the displacements have evolved gradually under sustained self-weight rather than correlating to any specific set of external loading conditions. Self-weight was seen to be the driving factor rather than lateral pressure from the earthen rampart because the walls displace under sections with parapets where there is extra self-weight, rather than under the gun embrasures.

Figure 5: Model of Prince of Wales Fort s' Multi-wythe wall a) Geometry and boundary conditions b) Parameterized Random Field model (colours represent variation in material properties) c) UngROUTED model

The models were run under two sets of conditions; first as an assembly of stones with no mortar present (see Figure 5c) using the simplified micro-modeling approach, and then with grouting added to the wall, thereby filling all voids using the detailed micro-modeling approach. UngROUTED wall cross-sections all collapsed before the full gravity load was applied (typically soon after ten percent of the gravity load was applied). A comparison of four of the ungrouted wall models appears in Isfeld and Shrive [23] where the mesh density and geometric model were established.

A probabilistic methodology was adopted for considering the randomness of material properties. To do so, a RFFEM was adopted. This method uses random field theory to consider the variance in the determination of the individual masonry material components (e.g. stone and grout layer). The RFFEM was developed by Moradabadi et al. [53] as an extension of the FEM to add randomness to different portions of the FEM model. Figure 5b shows the parametric random field model.

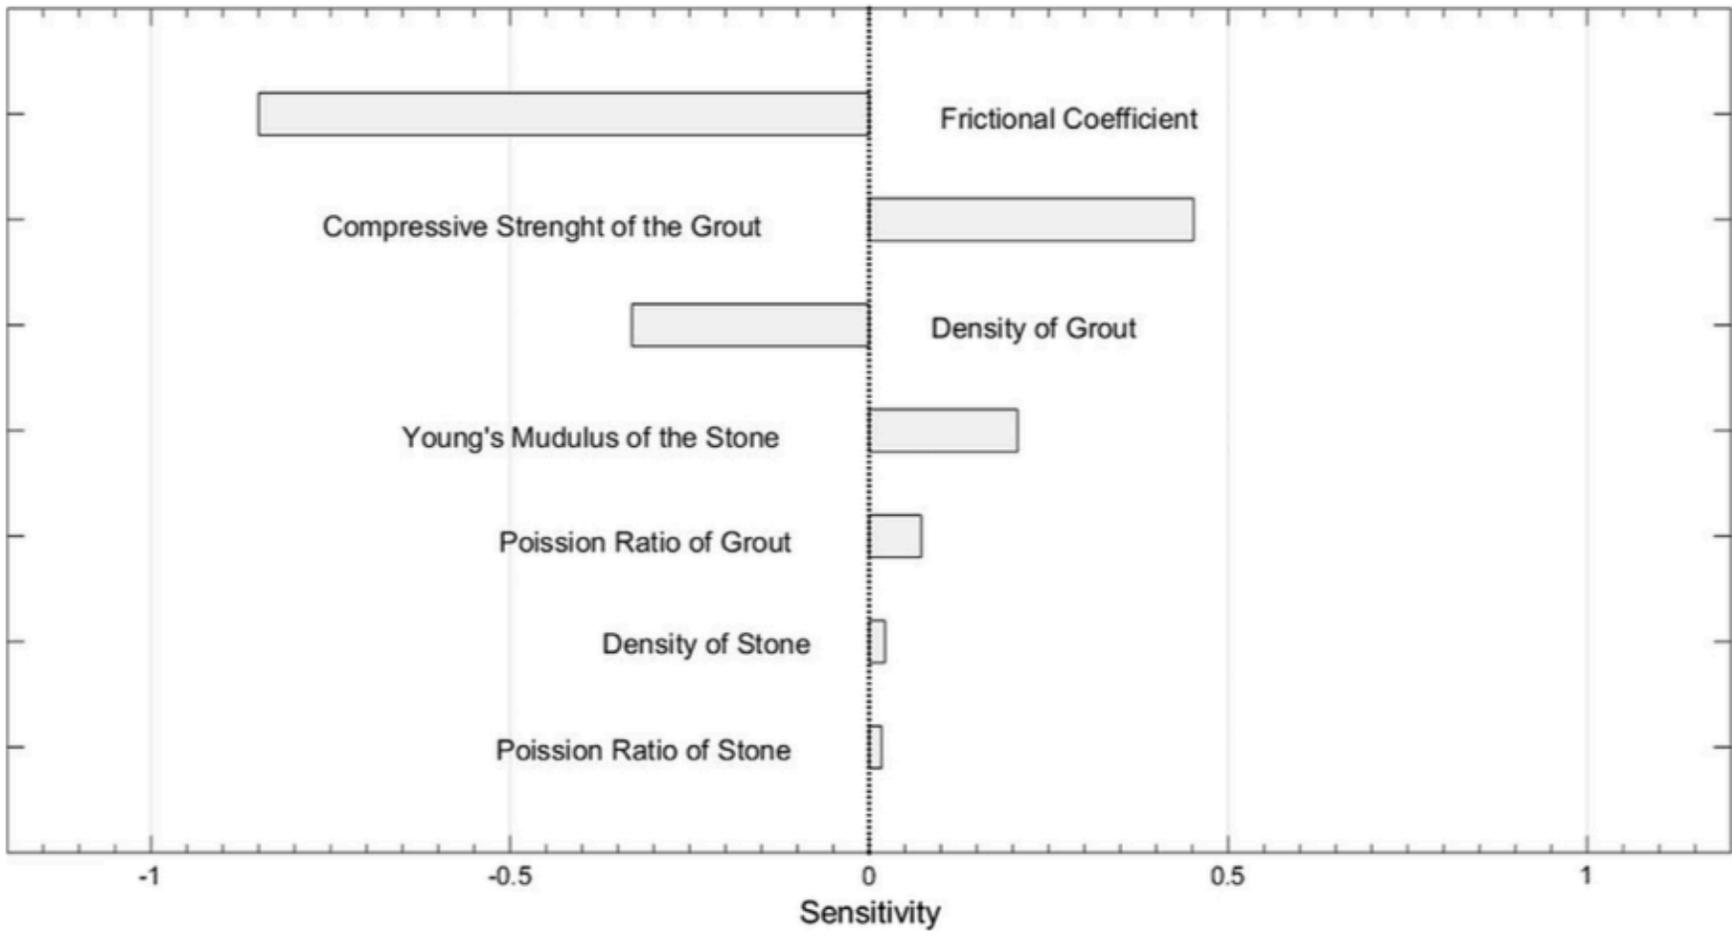
Figure 9: Tornado plots of preliminary results for PRCC sensitivity analysis

As hidden interactions may have a significant effect on the decomposition of the variance [54], and to remove the influence of co-variances on the correlation between a given input variable, X_i , and the output variable, $f(X)$, the partial rank correlation coefficient (PRCC) was used to compare further the sensitivity of the model for each input variable (for additional background on PRCCs, see [55, 56]). The tornado sensitivity plots for the 7 variables are presented in Figure 9, which shows the ranked correlation between each variable of the system with the lateral displacement. The PRCC analysis shows a negative sensitivity of the displacements to the grout density, while the scatter plots had indicated a positive sensitivity. Similarly, the PRCC analysis shows a positive sensitivity of the displacements to the stone density, while the scatter plots indicate a negative sensitivity.

PRCC values are considered large, and subsequently influential, when they are greater than 0.5 or less than -0.5. A positive sensitivity or PRCC value for a given parameter indicates that increasing the magnitude of the parameter will lead to increased lateral displacements in the wall section, while a negative value indicates an increase in the parameter would decrease the displacements. The only parameter in this analysis to have a large PRCC value was the frictional coefficient. Regression analysis on the scatter plots of Figure 8 and the PRCC sensitivity analysis in Figure 9 show the lateral displacements to be most sensitive to the frictional coefficient. This result reinforces the importance of bond development between the stone masonry units and injected grout, which has been the focus of a previous study [57]. Additionally, grout density and compressive strength, and stone modulus were found

to have a greater influence on the lateral displacements than the stone's density or Poisson's ratio or the grout's Poisson's ratio. However, these sensitivities are minimal compared to the frictional coefficient and all fall outside the influential range (> 0.5 or < -0.5).

As previously stated, Figure 9 clearly shows that the frictional bond is the most critical factor governing displacements, with the grout strength having much less influence. With the sensitivity of the model to the frictional contact clearly established, any reduction in contact area would lead to an increase in lateral displacements. In practice, to ensure sufficient contact and bonding between added grout and in-situ stones, grout properties such as injectability and shrinkage resistance should be carefully considered. Shrinkage of the grout would reduce contact between the grout and stones, thereby unintentionally preventing full realization of the grouting potential by decreasing the contact surface. Similarly, insufficient penetration of the grout into the voids would reduce the amount of contacting surfaces, as less grout would be introduced into the wall.

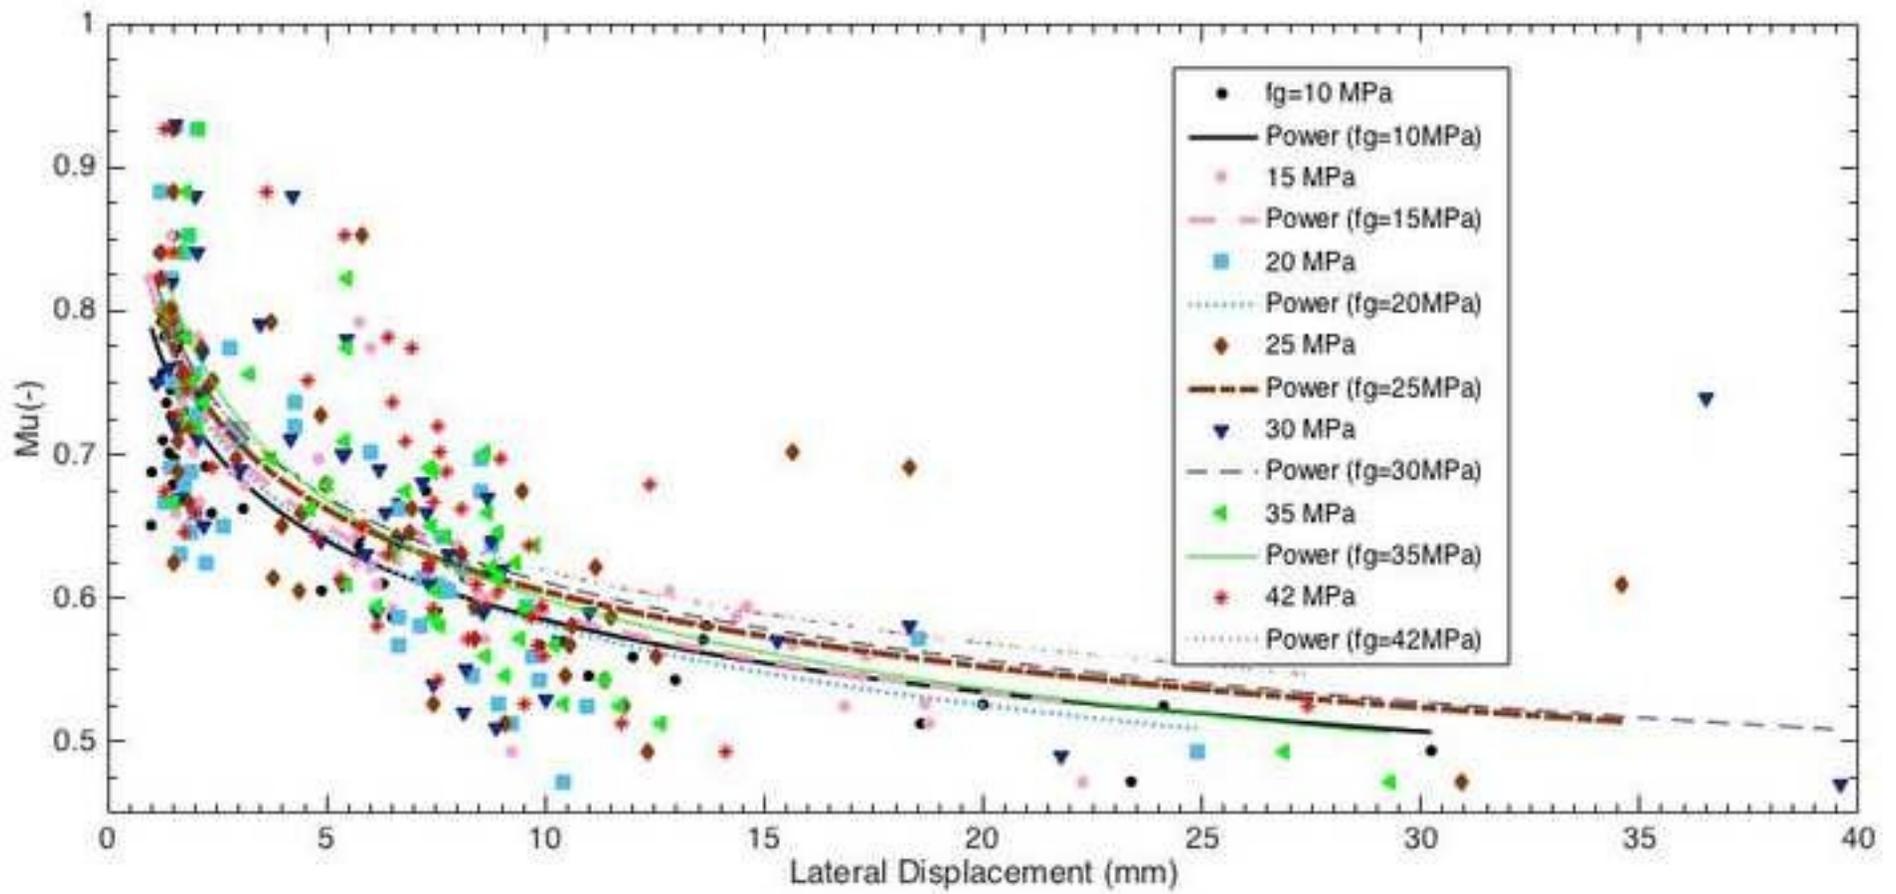
In Figure 10 the lateral displacements are plotted against the frictional coefficient at seven grout strengths, with a power relationship used to show how the displacements vary with increasing friction levels. The displacements are not as strongly dependent on the grout strength as on the coefficient of friction; a finding consistent with the sensitivity analysis, and again emphasizing the importance of the

bond between the grout and the stones. Under a very low frictional coefficient there is significant scatter between the lateral displacements for the seven different grout strengths. The average displacements are largest for the two lowest strength grouts (10 MPa, and 15 MPa). However for the 20 MPa grout, the average displacements are the lowest of all the models, lying near the 42 MPa grout. The grout strengths 25 MPa, 30 MPa and 35 MPa are closely grouped at the lowest frictional coefficient, and have intermediate displacements compared to the other grout strengths. Consequently, there is no wholly consistent relationship between the grout strength and wall displacement at this friction level. The same occurs with the highest frictional coefficient. As the frictional coefficient is increased, the displacement ranking of the seven lines of fit changes, with the smallest displacements and largest displacements found for the 10 MPa and 42 MPa grouts, respectively. This could be related to the location at which failure is initiated in the wall section. If the point of failure initiation is altered as a result of the change in frictional coefficient and grout strength, further nonlinearity is introduced. Consequently an increase in grout strength at a given frictional coefficient would not necessarily lead to a reduction in the lateral displacement.

Figure 10: Lateral displacements vs. frictional coefficient for each grout strength

The initial analyses showed the importance of the contact criteria, notably the coefficient of friction (or bond). As grout strength appeared to have the next greatest influence on displacements (Figure 9), the lateral wall displacements for seven grout strengths, within the initial range, were considered individually. For each of the seven cases, the grout's compressive strength was modeled with a normal distribution, taking the mean equal to the f_g values shown in Figure 10, and the coefficient of variance of f_g distributed through the model was equal to 0.5%. All other material properties were applied according to Table 1. The results from this analysis are shown in Figure 10.
