1 **LASER SCANNING-BASED DIAGNOSTICS IN THE STRUCTURAL ASSESSMENT OF**
2 **HISTORIC WROUGHT IRON BRIDGES**

26 This paper introduces a workflow to create the geometric documents for conducting finite element
27 based structural assessment of wrought iron bridges using laser scanning data as the input dataset.
28 First, a methodology for identifying actual cross-sections of the bridge components based on a point
29 cloud obtained from a terrestrial laser scanner (TLS) is presented. Next, a non-parametric regression
30 kernel density estimation is employed to determine the overall bridge dimensions to populate a
31 computation model by projecting the position of the web and/or flange surface of the cross-section
32 (appearing as local maximum peaks of a probability density shape). The process is demonstrated with
33 respect to the previously undocumented Guinness Bridge in Dublin, Ireland to determine the bridge's
34 behaviour. The successful generation of this model proves that TLS can surpass other common

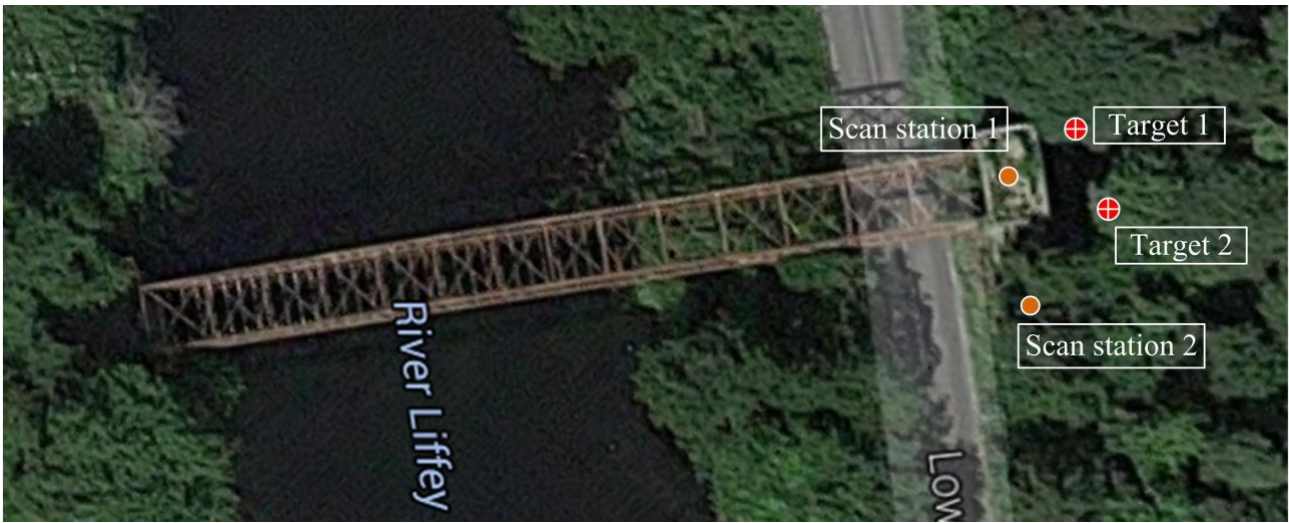
Figure 1. Positions of scan stations and targets

148 Because of the absence of a river bank on the south side, no public access was available there. On
149 the north side significant trees also limited the access. Thus, only two scan positions could be set
150 up—both from the north (Figure 1). Station locations were chosen to maximise a clear line of sight

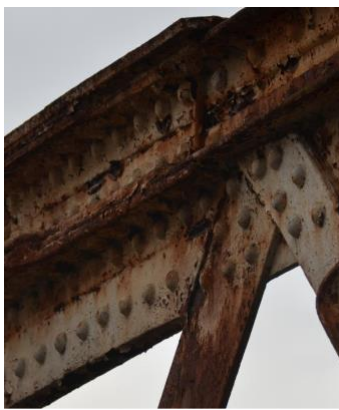
b) Sketch a cross-section based a point cloud

c) Estimate a cross-section based a sketch section

Figure 4. Evolution of point cloud to a final cross-section of the top chord (Note: value in brackets is in Imperial units). a) Photo of a bottom chord; b) Sketch of a cross-section outline based on a point cloud; c) Estimate of a cross section based on the sketched section; d) Finalised cross-section based on a library entry

193 To obtain the actual cross-section of the structural elements, a local coordinate system was defined
194 for the structure by defining a User Coordinate System (UCS) in the AutoCAD programme, where
195 the z-axis was parallel to the longitudinal direction of the component and its cross-section lay on the
196 x-y plane. Following alignment, the point cloud of the cross-section of a given structural component
197 was cropped using the ‘Clipping’ tool in Leica CloudWorx (Leica Geosystems AG, 2016). An
198 iterative procedure for section identification was applied. The process is illustrated in Figures 3 and

199 4, being applied to the bottom and top chords, respectively. Photos of the structural members further
200 supported the identification of the components (Figure 3a and 4a).

202 After projecting the point cloud of the cross-section onto the x-y plane, an outline of the section was
203 first sketched manually using in-built AutoCAD tools (Figure 3b and 4b). Using photos as
204 supplemental information, the individual components of each cross-section were identified. A
205 possible section shape for each component was then estimated. This was necessary due to the highly
206 complex, composite geometry of the pieces. For example, the bottom and top chord were made from
207 an L section and multiple plates (Figure 3c and 4c).

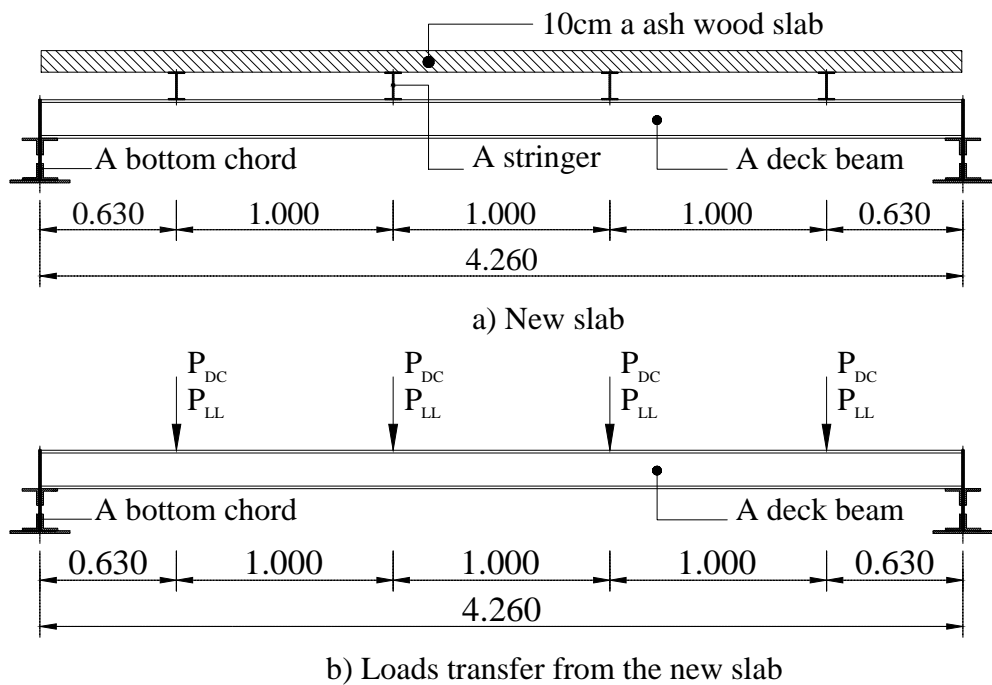
Figure 8. A new slab design. a) New slab; b) Loads transfer from the new slab

305 Since Cases 1-3 had no slab, the bridge was only subjected to self-weight, which was defined by the
306 cross-sectional area, the lengths of the structural members, and a mass density. In Case 4, the bridge
307 was subjected to both dead load (DL) and live load (LL). The dead load from the slab system
308 (stringers and slab) was computed from the self-weight of the stringer at 13 kg/m and ash wood, with
309 a mass density by 710 kg/m³. In addition, for LL, a modern pedestrian load of 4.3 kN/m² equivalent
310 to 90 psf was selected according to AASHTO (2012). The concentrated loads from the slab system
311 transferred to the deck beam are shown in Figure 8b. However, since the distances between the deck
312 beams differ, the dead load (P_{DL}) and live load (P_{LL}) were applied to the deck beams in accordance
313 with their spacings (0.3kN and 1.4kN for the first and last beam, 0.7kN and 3.5kN for the second and

314 the penultimate deck beams, and 0.8 kN and 4.1kN for others) [Figure 8b]. Finally, load combinations
315 under strength I (STR1) and service I (SER1) according to AASHTO (2012) were used in this
316 assessment. For STR1, the load factors for DL and LL were respectively 1.25 and 1.75, while in SER1
317 all load factors were 1.0.
