**A Report on the Field Activities
of the Dakhleh Oasis Project
during the 2003–2004 Field Season**

by
A. J. Mills

with
R. S. Bagnall, C. A. Hope,
M. R. Kleindienst and F. Leemhuis

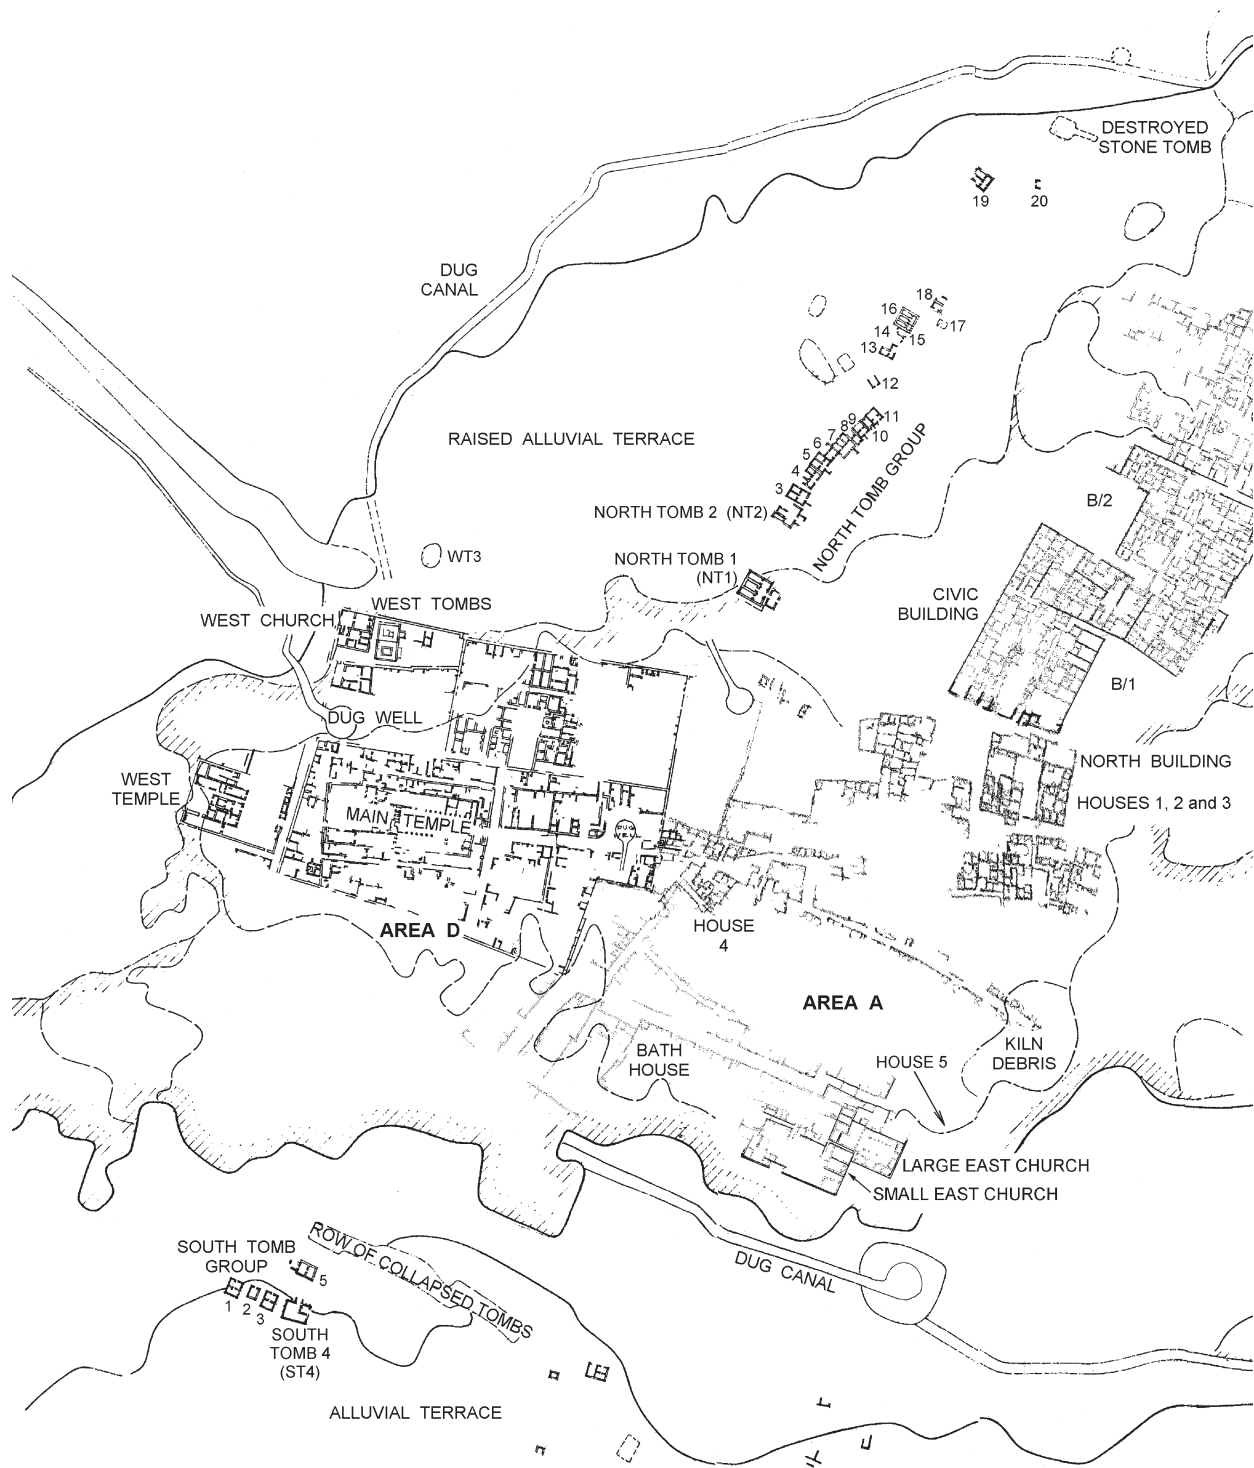
Figure 1 Plan of Ismant el-Kharab showing main excavation areas (original drawing by J. E. Knudstad supplemented by J. Dobrowolski and B. Rowney). Scale 1:5000.

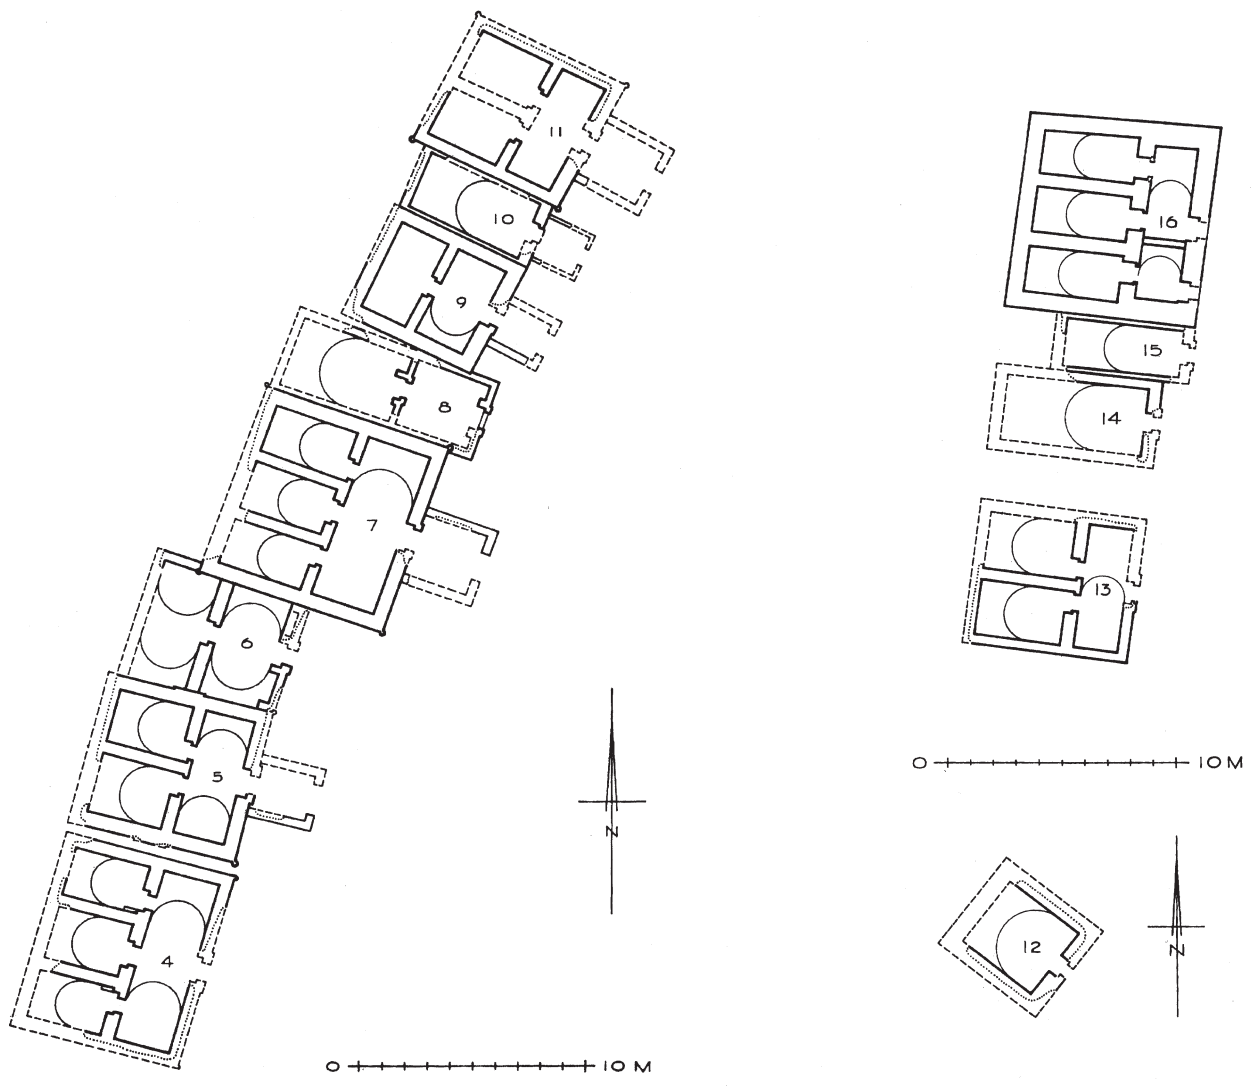
Figure 2 Plans of North Tomb Group (Tombs 4 to 11 and 12 to 16), Ismant el-Kharab.

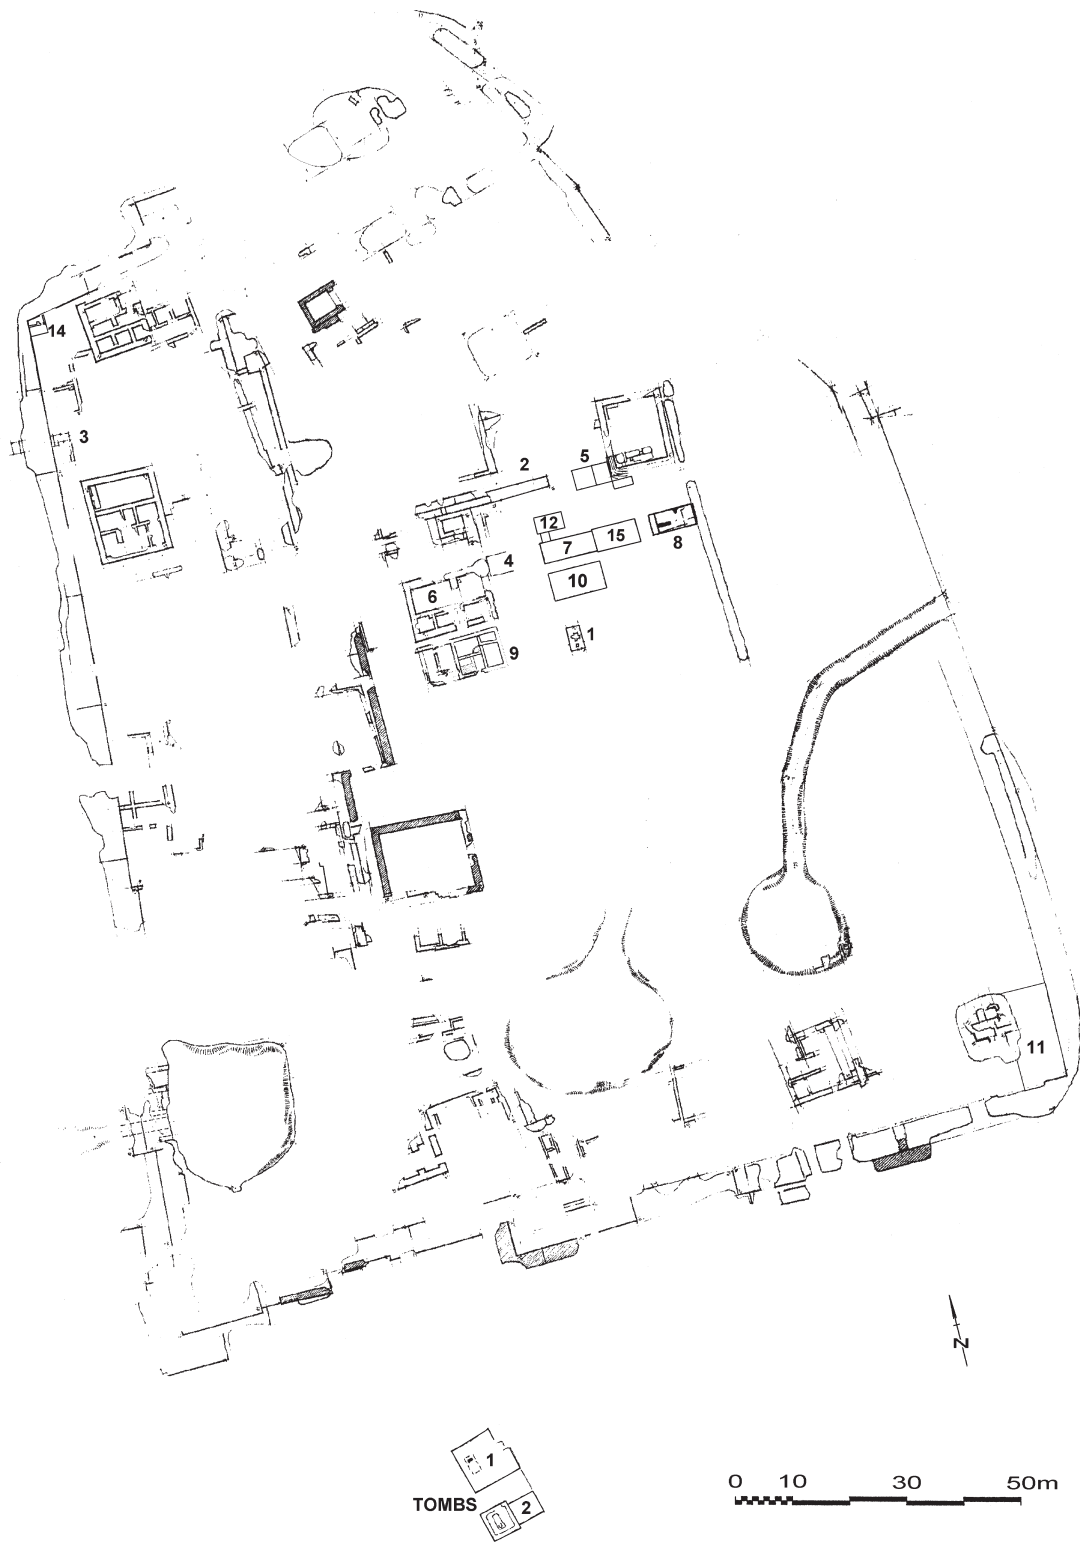
Figure 3 Plan of Mut el-Kharab showing the location of the excavated trenches.

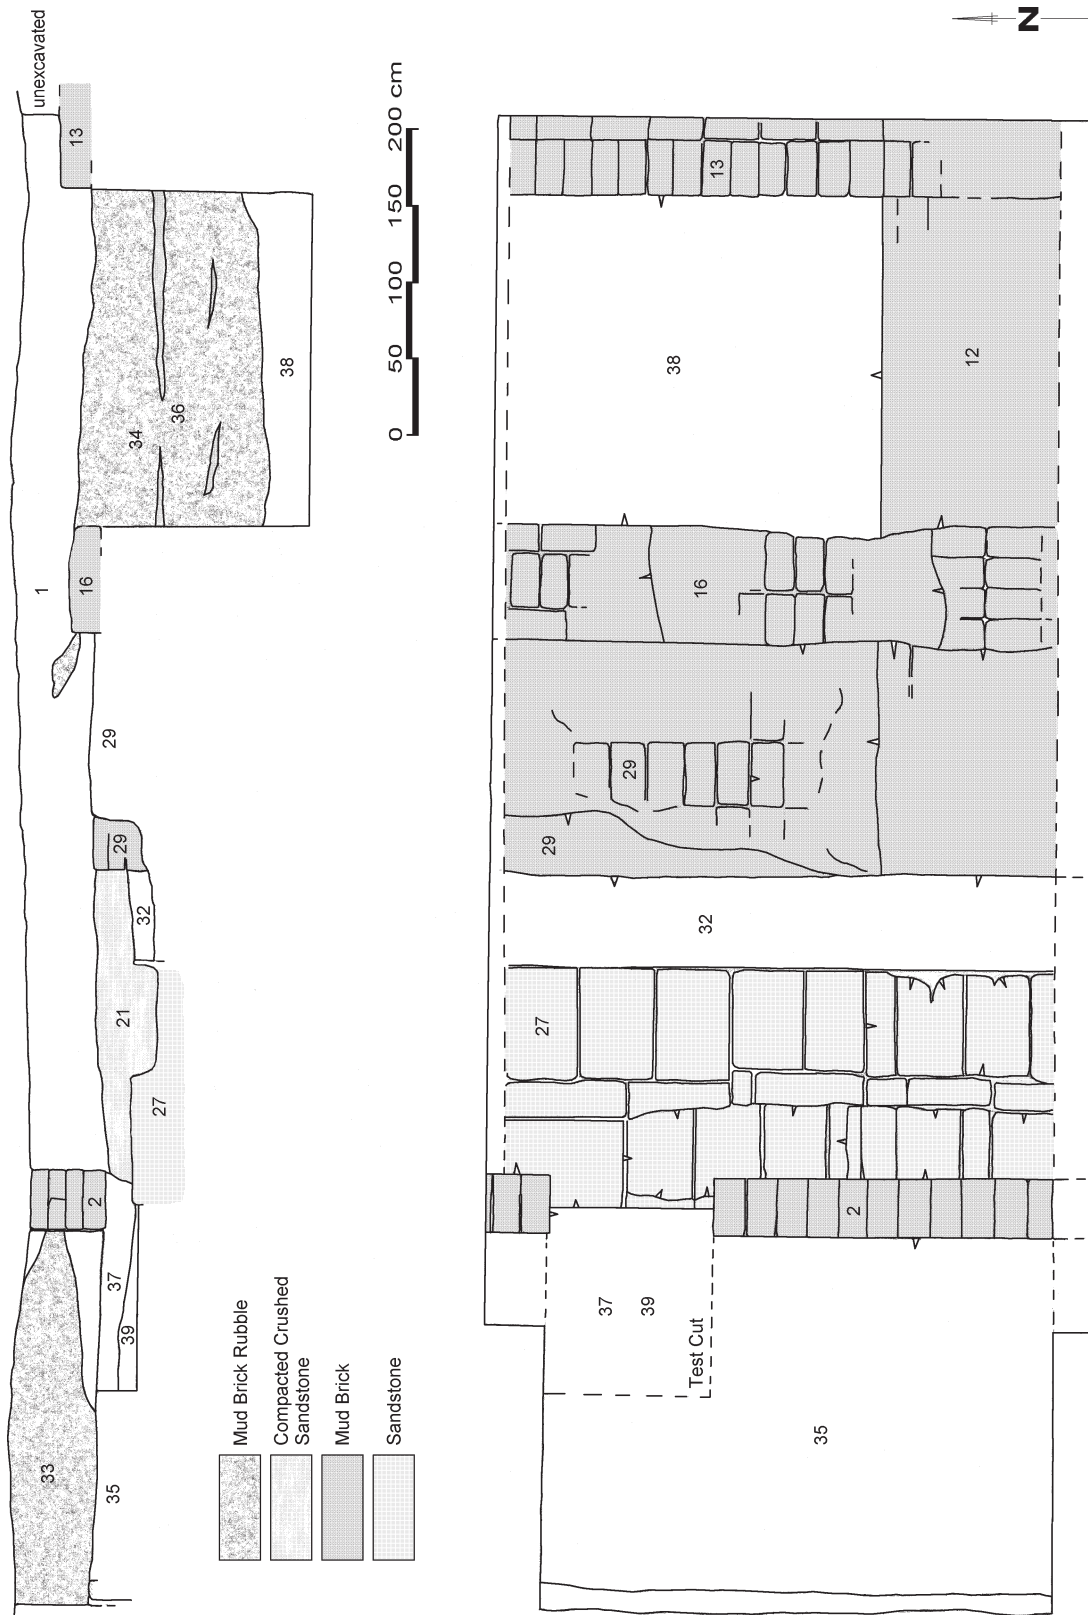
Figure 5 Mut el-Kharab, Trench 15: north section and plan upon completion of excavation.

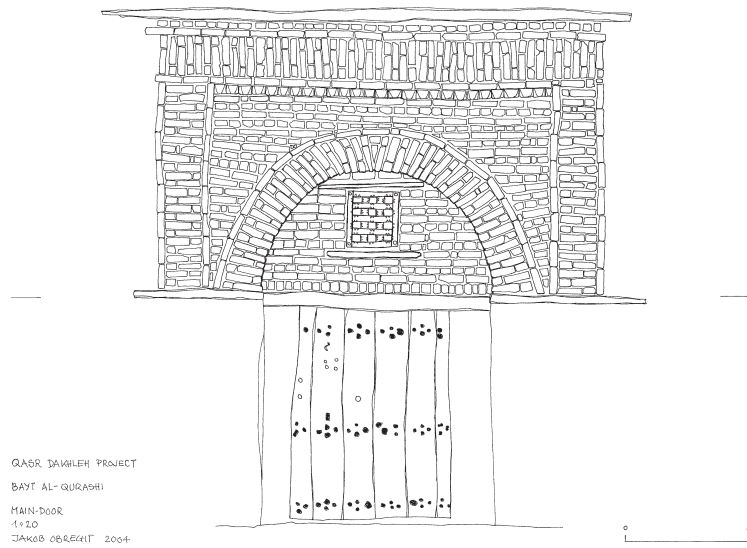
Figure 25 Drawing of the main entrance of Bayt al-Qurashi.

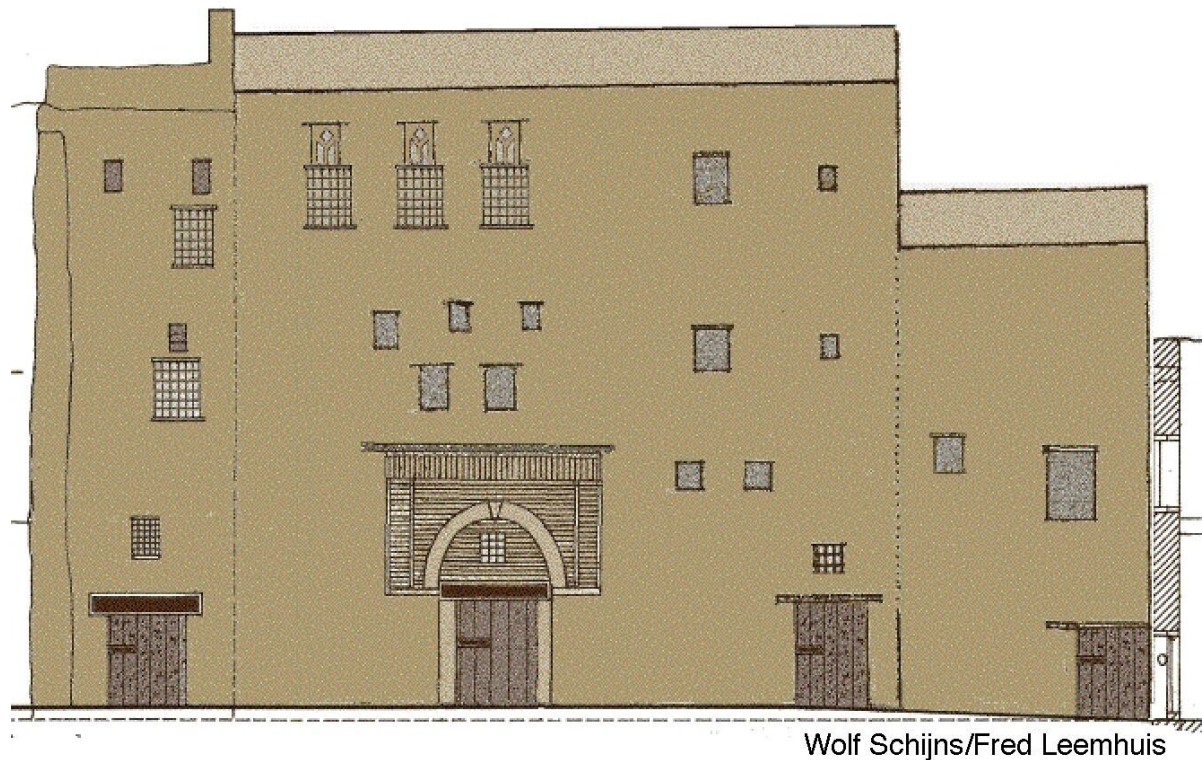
Figure 27 Reconstruction of the façades of Bayt al-Qadi and Bayt al-Qurashi.

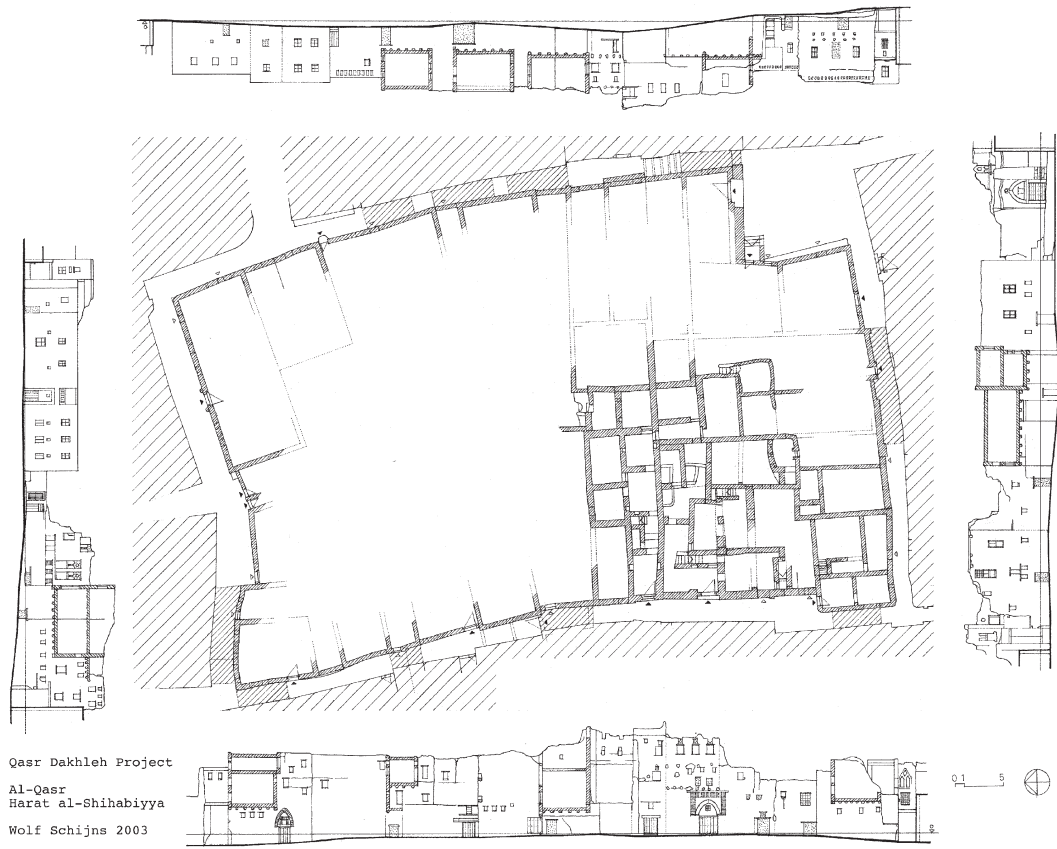
Figure 28 Plan of the Harat al-Shihabiyya.

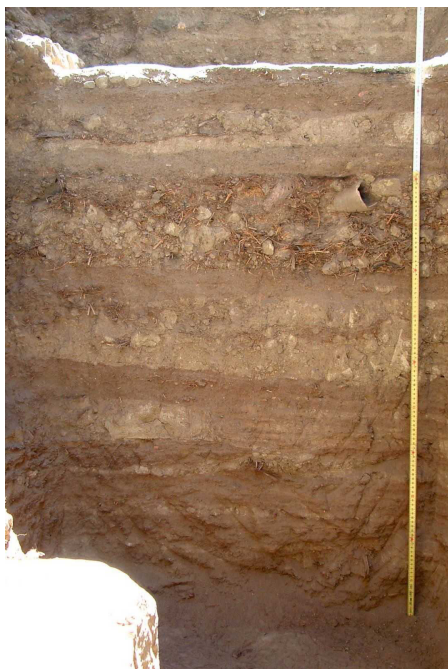
Figure 29 Stratigraphy on the southern side.

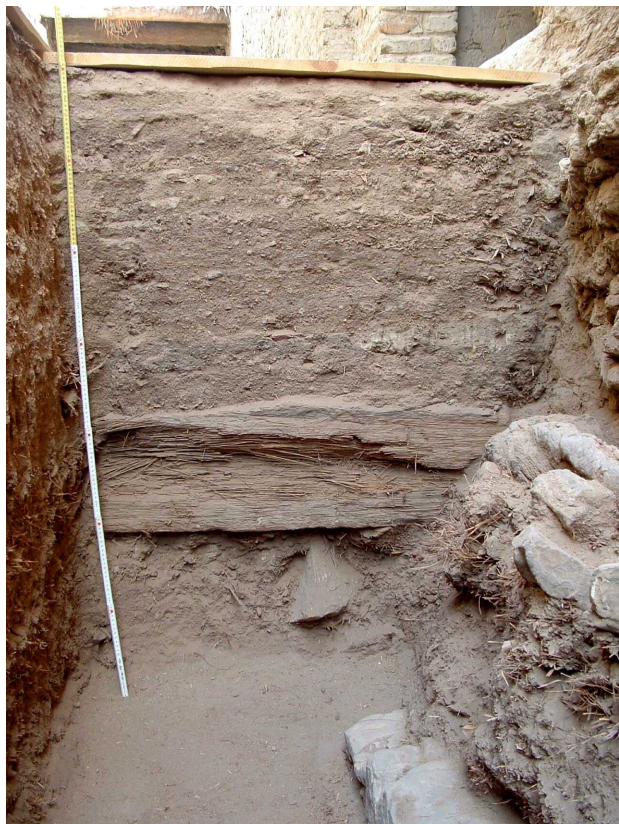
Figure 31 Stratigraphy on the northern side.

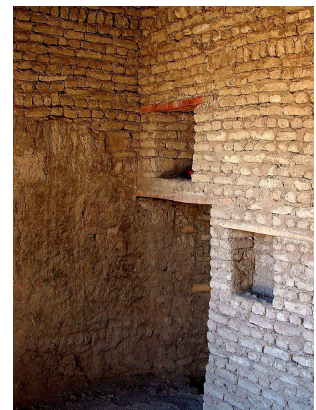
Figure 43 Rebuilt wall between BQur 2 and 5.

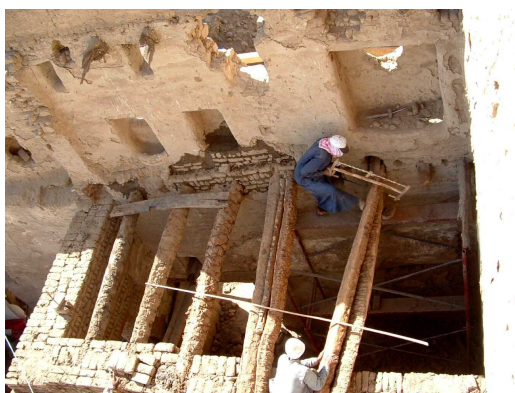
Figure 44 Putting floor beams for the first floor of BQur 1.

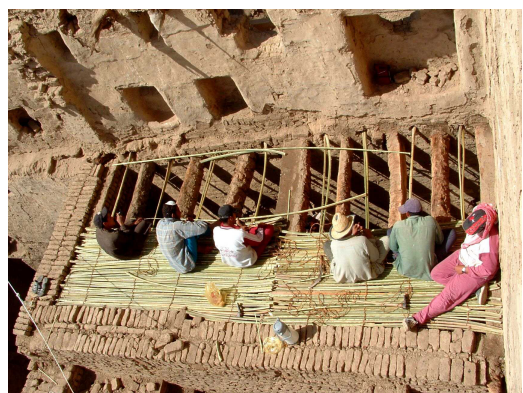
Figure 45 Laying the palm nerves for the first floor of BQur 1.

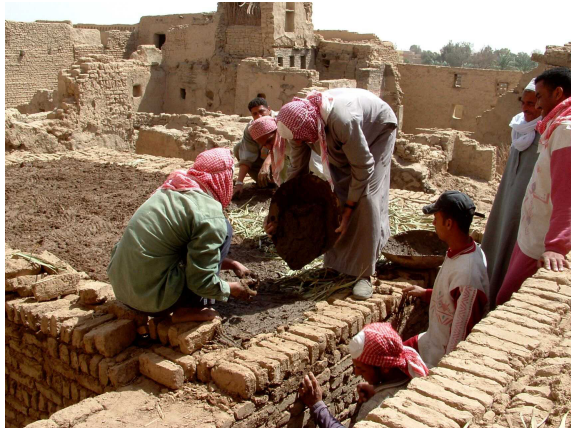
Figure 46 Laying the mud layer for the first floor of BQur 5.

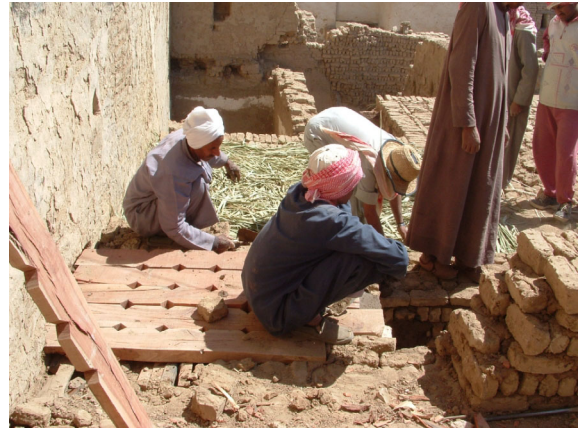
Figure 47 Construction of wooden ventilation grid on the first floor above the entrance to the stairs.

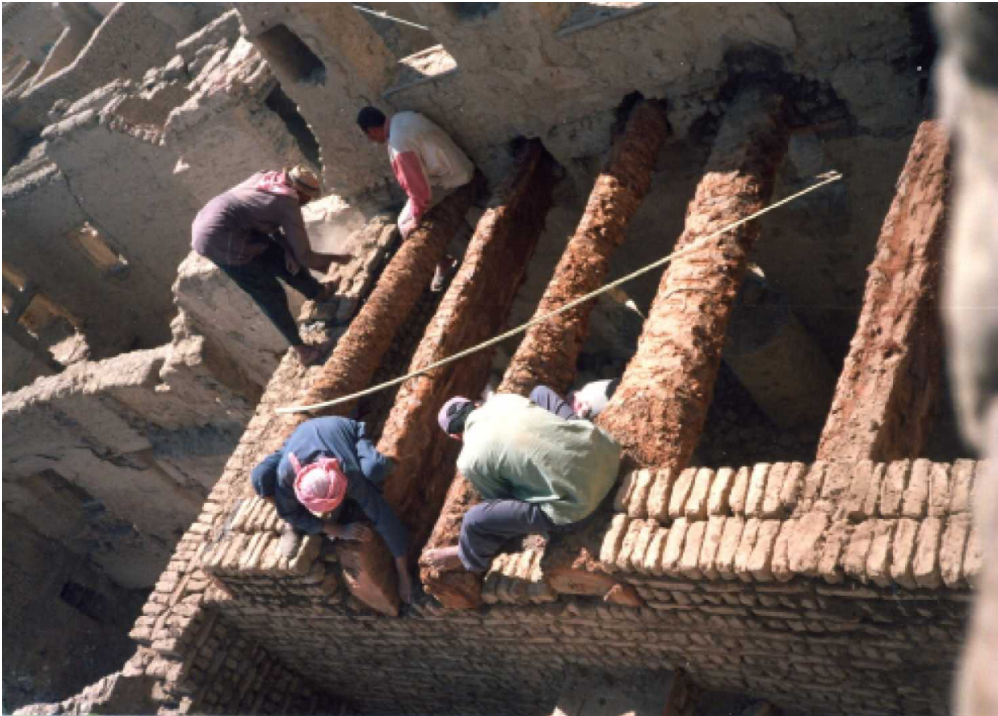
Figure 49 Putting floor beams for the second floor of BQur 1.

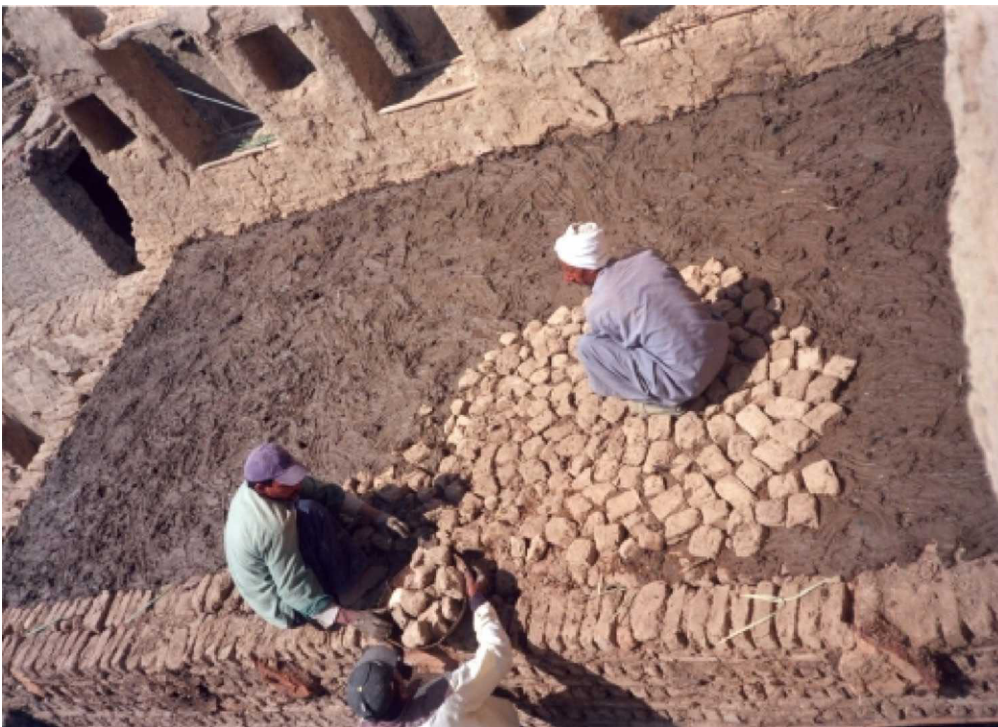
Figure 50 Putting on the top layer of the second floor of BQur 1.

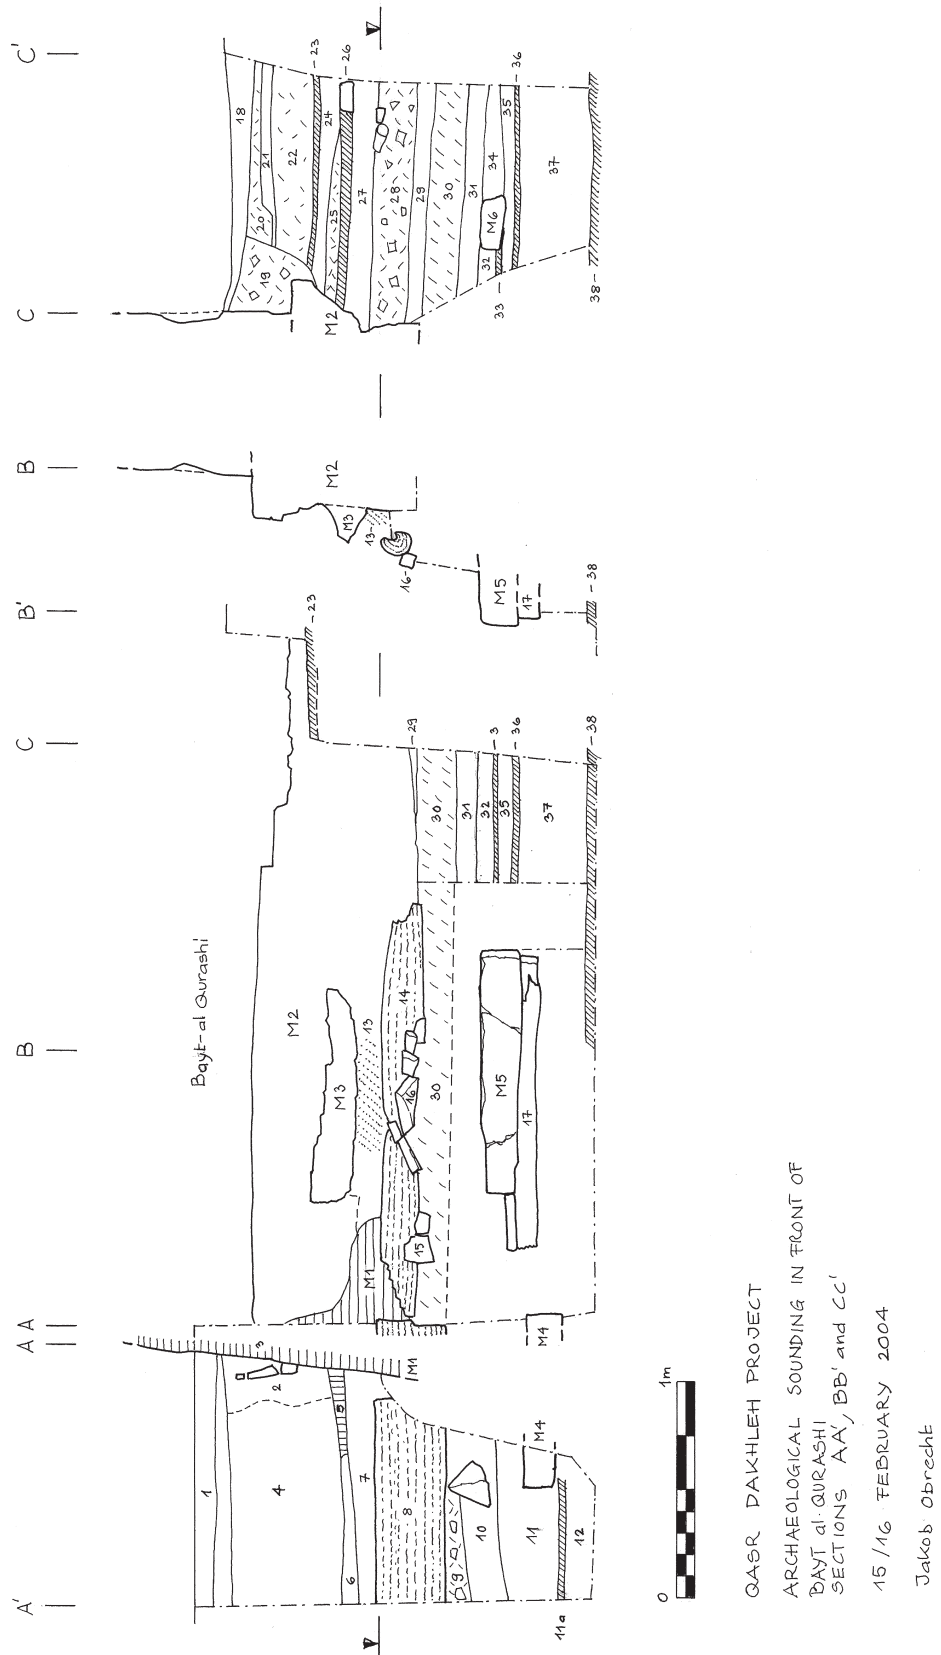
Figure 51 Stratigraphy of the trench in front of Bayt al-Qadi and Bayt al-Qurashi.
